FACILITY REVIEW

NOVEMBER 2018

A report on the condition of
facilities at Missouri's public
colleges and universities

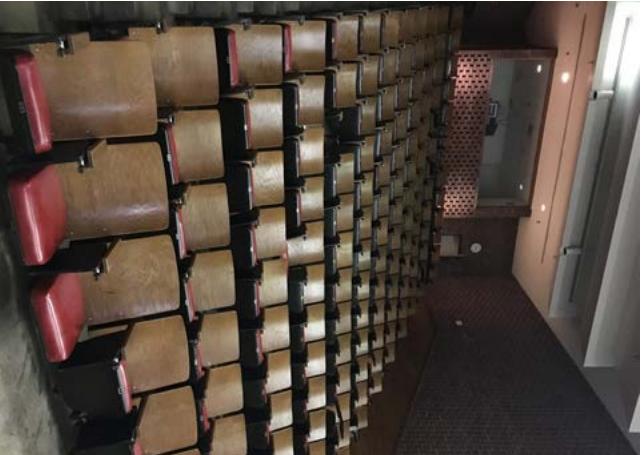
An outdated lecture hall

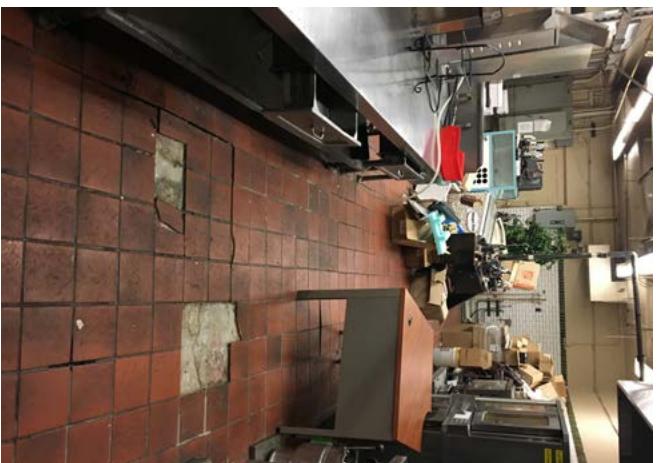
Unusable space

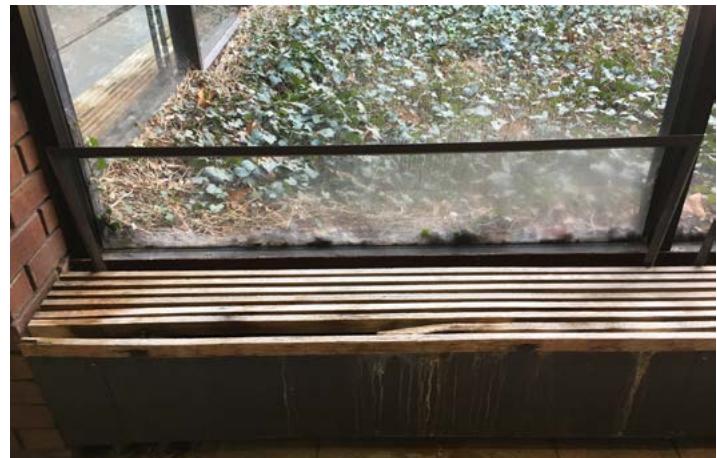
Window repairs and bench replacements needed

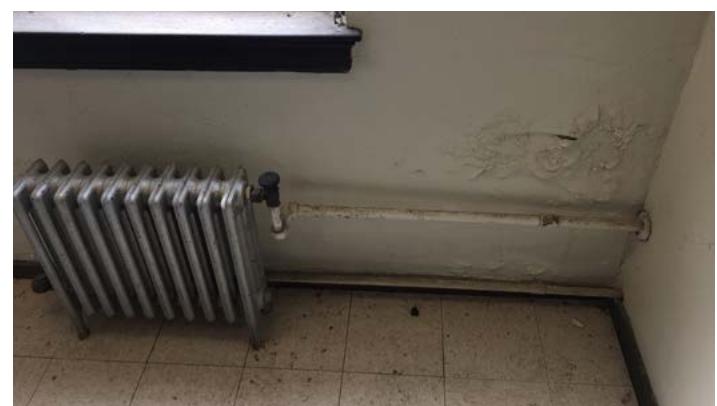
Asbestos floor tiles, water infiltration and outdated heating

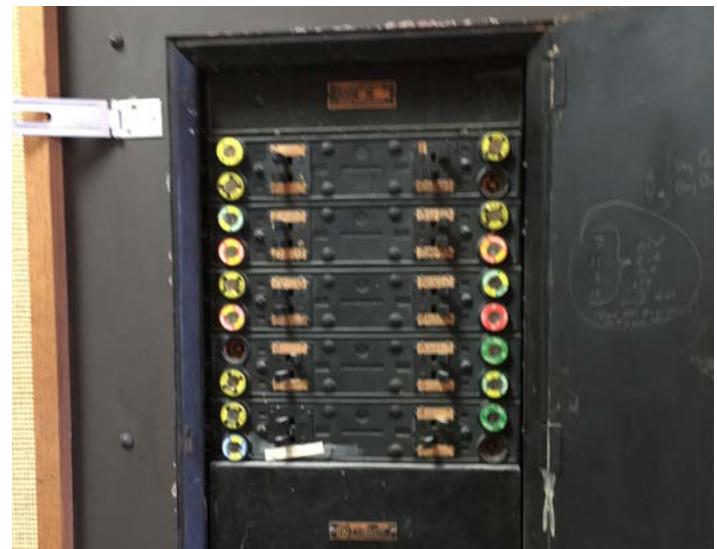
An outdated fuse box with outdated fuses

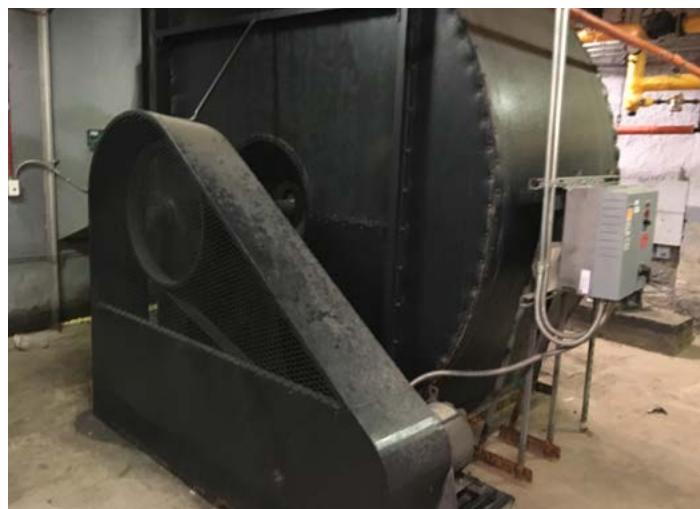
An outdated air handler still in use

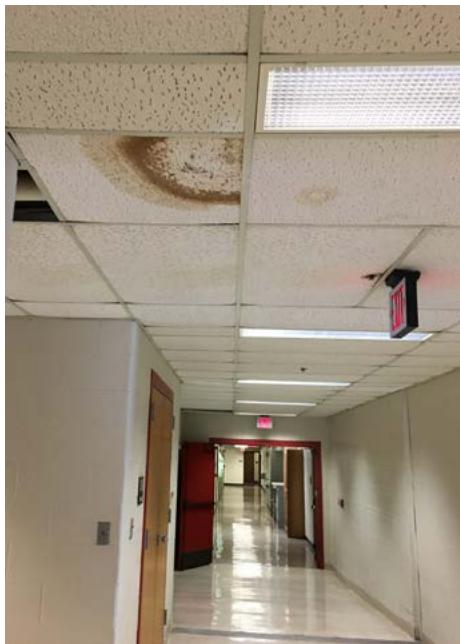
Water issues, leaky pipes, and condensation affecting ceilings

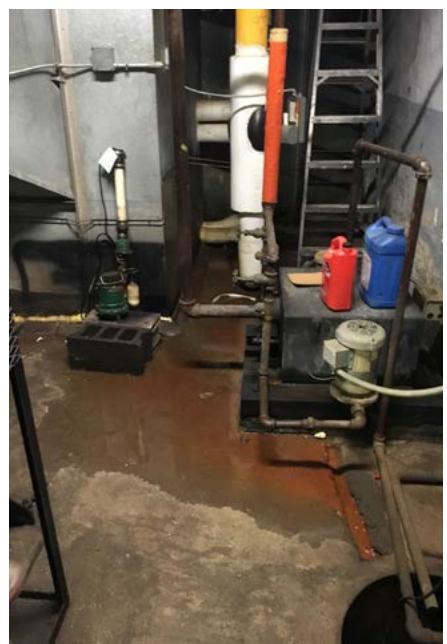
Water problems caused by old pipes

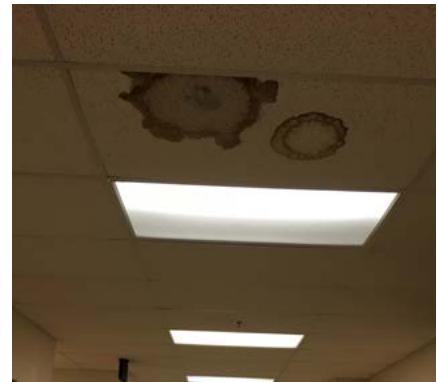
Throughout the MSSU campus, there are numerous chillers, air handlers, boilers, and fan coil units that are many years beyond their useful life and are in need of replacement. A planned replacement of these units, before an emergency occurs, is more efficient and cost-effective than using costly temporary units. Replacing outdated units with more efficient ones will save operational dollars in the long term.

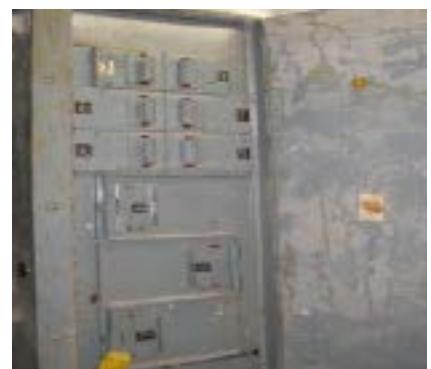
4. Cheek Hall

The building has been reconfigured many times over the years to meet different needs. Cheek Hall now requires major modifications. This renovation project will redesign, modernize, and upgrade the grossly inadequate facility. The HVAC system is more than 50 years old and parts of the electrical system are 60 years old. These will be updated or replaced. The building's exterior is also very energy inefficient. Replacing the exterior will help with future energy savings. As the university's primary computing center, Cheek Hall contains the servers and networking components that host the university's core administrative and academic software. Services provided by this center are mission-critical for daily operations on the campuses of Springfield, West Plains, and Mountain Grove. Current physical conditions and environmental controls expose the university to unnecessary risks. These exposures could cause significant system downtime, information security ramifications, and disruption of university activities.

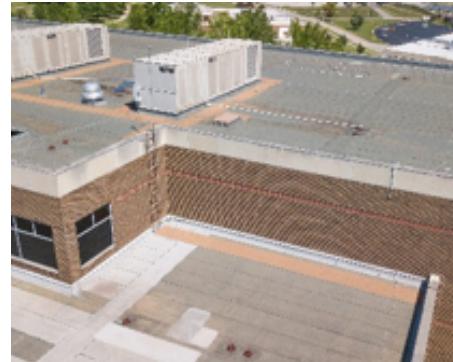
3. Campuswide Roof Replacement/Overlay

Several of Western's academic buildings have deteriorating roofs. The majority of the buildings have flat roofs that are beginning to weather, buckle, and crack; allowing moisture to penetrate into the insulation and damage ceiling tile, walls, floors, and furniture. The university performs regular maintenance on its roofs and has had to completely remove existing insulation and roof materials to install new ones.

Missouri Western has over 374,000 square feet of roof space across nine buildings, over 65% is at or beyond its expected useful life. Forty percent (149,600 sq. ft.) of this roof space is 15 years old with 25% (86,750 sq. ft.) of the roof space older than 20 years old. Western presently has sections that were installed in 1987 (31 years old). Roofs that exceed 15 years of age become very high maintenance due to deterioration; in some cases, maintenance is applying patches on top of patches. There are roof areas where the seams are pulling apart, demanding regular attention and a constant stream of resources. The areas around roof penetrations continue to allow moisture to enter the facilities, causing significant structural deterioration.

It is essential that repairs are made to the university's roof systems that are over 15 years old to prevent further damage and repair costs to the university. Addressing these repairs now will eliminate potential health risks (mildew/mold issues) which arise due to wet conditions. Maintenance costs will be greatly reduced and the institution will see a decrease in energy usage due to new energy-efficient insulation once the roof repairs/replacements have been completed.

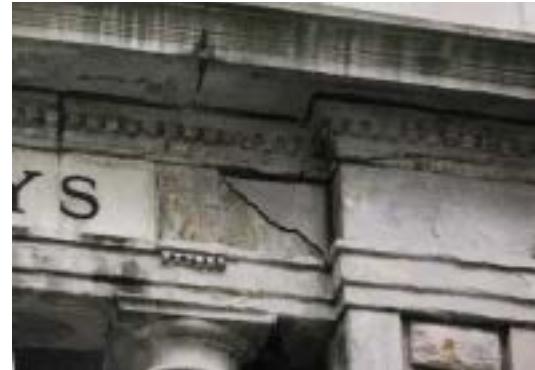
The 20-year old single-ply roof is reaching useful life expectancy and is in immediate need of replacement. Replacing the roof will avoid additional cost resulting from water intrusion due to roof leakage. The façade is in fair to poor condition currently. The building facades have aged considerably and have deteriorated due to absorption of moisture into the stone façade elements, leading to stone spalling, scaling damage, damage to mortar joints, and corrosion-related deterioration. Existing waterproofing elements are nearing the end of their useful lives and supplemental waterproofing measures are needed to prevent future damage and protect existing construction. The deterioration and failure of waterproofing is allowing seepage of moisture into the walls, which is subsequently leading to damage of the interior finishes of the building. A comprehensive repair program is needed to mitigate leakage, restore the deteriorated façade, and protect and extend the life of the building façade to the greatest extent feasible.

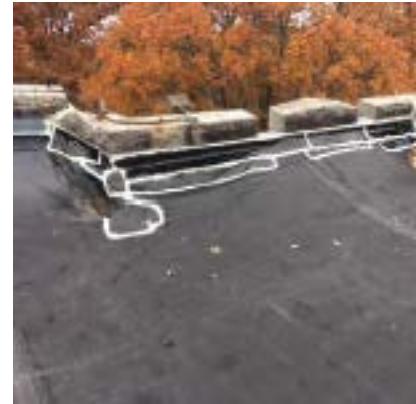
The building facades have aged considerably and have deteriorated due to absorption of moisture into the stone facade elements, leading to stone spalling, scaling damage, cracking and splitting, and damage to mortar joints. Existing waterproofing elements are nearing the end of their useful lives and supplemental waterproofing measures are needed to prevent future damage and protect existing construction. The deterioration and failure of waterproofing is allowing seepage of moisture into the walls. A comprehensive repair program consisting of stone replacement, stone patchwork, repointing of mortar joints, and application of water repellent sealers is required to properly maintain building envelope integrity.

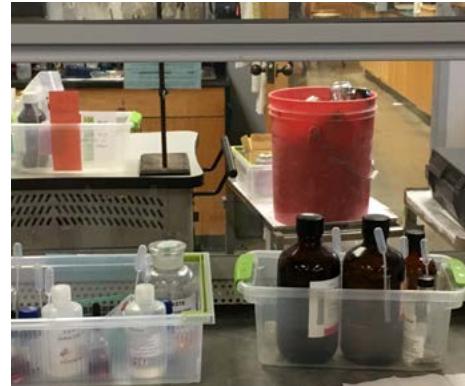
3. MCC–Penn Valley Classroom / Laboratory Renovation

MCC's Penn Valley campus buildings are nearly 50 years old. Much of the infrastructure is original. Classroom and laboratory space is poorly configured to meet modern best practices and industry expectations. This planned renovation will update building heating, ventilation, and air-conditioning systems; piping; electrical systems; restrooms; and classroom and laboratory configurations.

This renovation will allow MCC to execute the first step of a phased approach to modernizing both Penn Valley's infrastructure and learning environment to meet the growing needs of Kansas City's diverse downtown community.

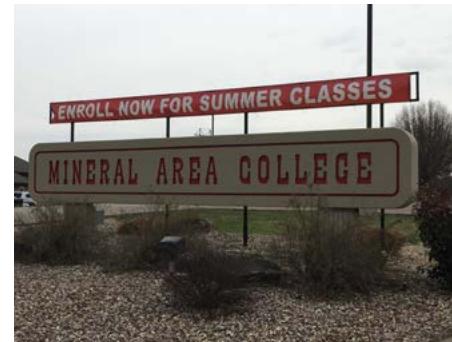
2. HVAC System Upgrade for Chiller/Boiler

The main campus of Mineral Area College was built in 1971. The original HVAC system was a chiller/boiler system using underground piping to connect buildings. Approximately 60% of current piping is original to these 1971 buildings; the remaining 40% was replaced due to deterioration and leaks in the last decade.

This proposed upgrade will eliminate the underground system entirely by more efficient air-cooled chillers and boilers designated for the buildings that use them. This will reduce the need for future and significant expenditures to maintain an aging infrastructure in the short-term, and will reduce operating costs through energy efficiencies.

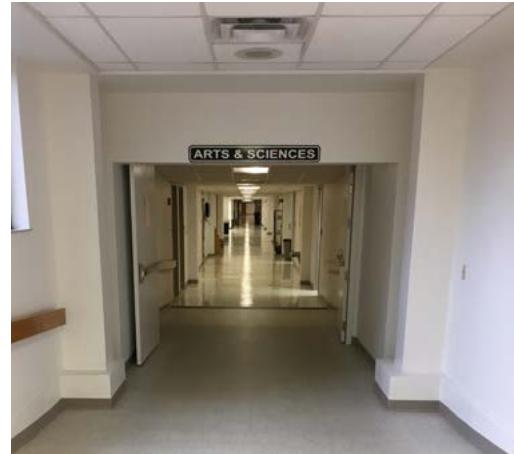
3. Arts & Science Remodel

The original Arts & Sciences Building was constructed in the 1970s. Although technological infrastructure has been added, flooring, ceilings, and walls currently in use are part of the original construction. This building consists of nine upstairs classrooms, two upstairs science labs, six classrooms downstairs, and various offices.

Remodeling this space, which houses the majority of arts and science courses, will create a more efficient and modern learning experience, allow for abatement of asbestos flooring, and will update the look of classrooms that have been largely untouched for nearly five decades.

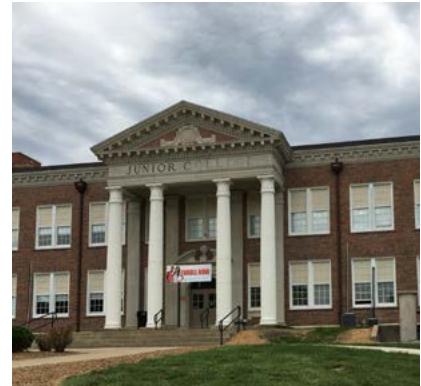
Windows throughout the building need to be replaced, exterior brick needs to be tuckpointed and sealed, and building concrete needs to be repaired.

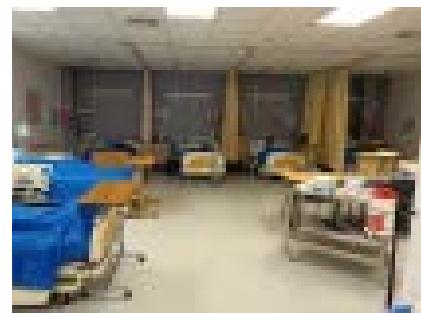
This facility was originally constructed in 1973 and was subsequently expanded in 1987 and 1989. Since its construction, the majority of this space has been used by the Health Sciences division. The exterior of the facility is in need of multiple improvements, including modifications to address water infiltration and to replace entrance doors to increase handicap accessibility. Lab space for nursing programs need to be improved to foster a better, more up-to-date learning environment. Additional insulation to the facility needs to be installed to provide cost-effective, energy-efficient spaces that are more comfortable for students, faculty, and staff. Hallways, offices, and restrooms need to be improved to meet capacity and modern demands.

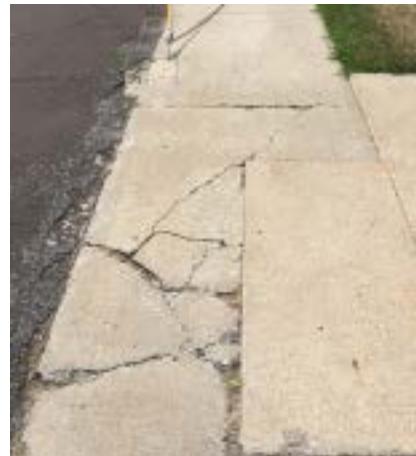
Several sidewalks around campus are in need of repair; many years of applying de-icing products to the sidewalks has caused them to deteriorate and fail.

Control joints, expansion joints, and broom-finished concrete surfaces have deteriorated to the point where they have become trip hazards. Winter freezing and thawing cycles have pushed the sidewalks apart vertically and horizontally, presenting a safety issue. Stone retaining walls that have been in place for many years have shifted under stress, causing them to bow outward and in some cases break. As a short-term measure, the maintenance department has occasionally reset some of the cap stones to help realign some of the walls, but over time they move outward again; this is partially because the walls were constructed before retaining wall drainage was introduced. New walls will have drainage pipe along with clean rock backfill to prevent future outward movement. Additionally, some walls are delaminating due to the use of weather-vulnerable soft stones, letting moisture penetrate the stone face and increasing the likelihood of failure.

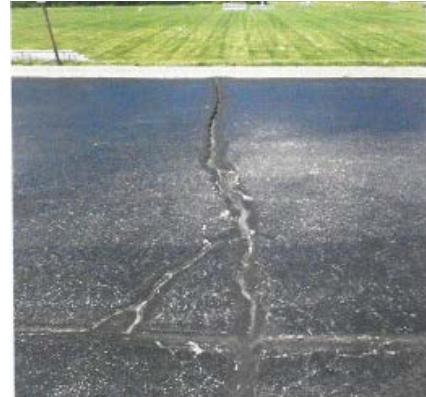
2. Asphalt Repairs

State Fair Community College has approximately 530,000 square feet of asphalt parking area and an additional 100,000 square feet (5 miles) of roadways and walking track. Although the college has made an effort to patch, crack seal, and seal coat on a routine basis there has been an uptick in defects and failures on parking lots and roadways. The specific defects — alligator cracking, block cracking, transverse cracking, edge cracks, potholes and depressions — are indicators of structural failure and indicate the need to remove a portion of the pavement layer and replace it with overlay to correct.

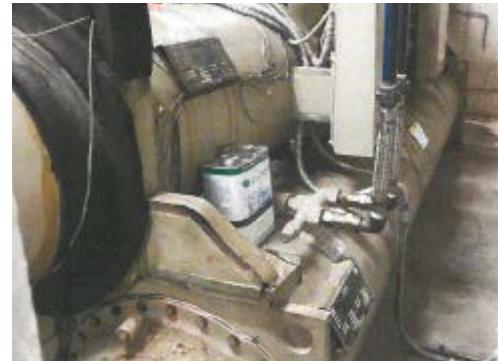
3. Yeater Chiller Replacement

The cooling system in Yeater Hall consists of two chillers; the oldest of which was built in 2005. One of the two compressors on the chiller leaks oil and causes the system to shut down. Replacement parts are no longer available. The compressor has been rebuilt on two previous occasions, and has started to leak oil again and cannot be repaired further. This system cools approximately 25% of the square footage of the campus, most of which is academic classroom space. The second chiller does not have the capacity to cool the space to an acceptable level during hot weather. This project provides for the removal of the existing chiller and replaces it with a 250-ton water-cooled chiller.

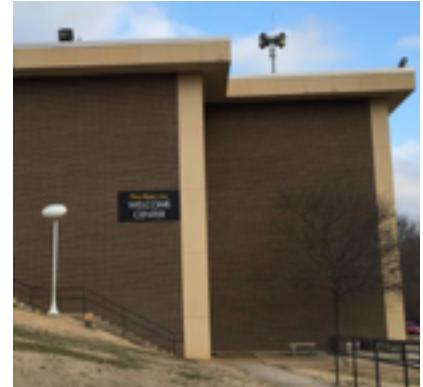
Currently, the main priority for Three Rivers is an exterior renovation of the Westover Building. The exterior is in need of an update to better fit into the character of the new and renovated buildings it faces to the north. Many of the fixtures and design elements are original to the building, which are older than can be found anywhere else on campus.

Many windows leak, causing water damage, and are energy deficient. This renovation will increase energy efficiency and save Three Rivers in long-term operational costs. Exterior siding contains asbestos panels; and the western entrance to the student welcome center has no protection from the elements. The roof is beginning to fail and needs remediation to preserve the integrity of the building and prevent future exorbitant expenditures.
